**Special Investigation Report - Derailments of
New York City Transit Authority Trains
Involving Traction Motor Mount Failures**

**DERAILMENTS OF NEW YORK CITY
TRANSIT AUTHORITY TRAINS INVOLVING
TRACTION MOTOR MOUNT FAILURES**

NTSB-TSR-SIR-82-2

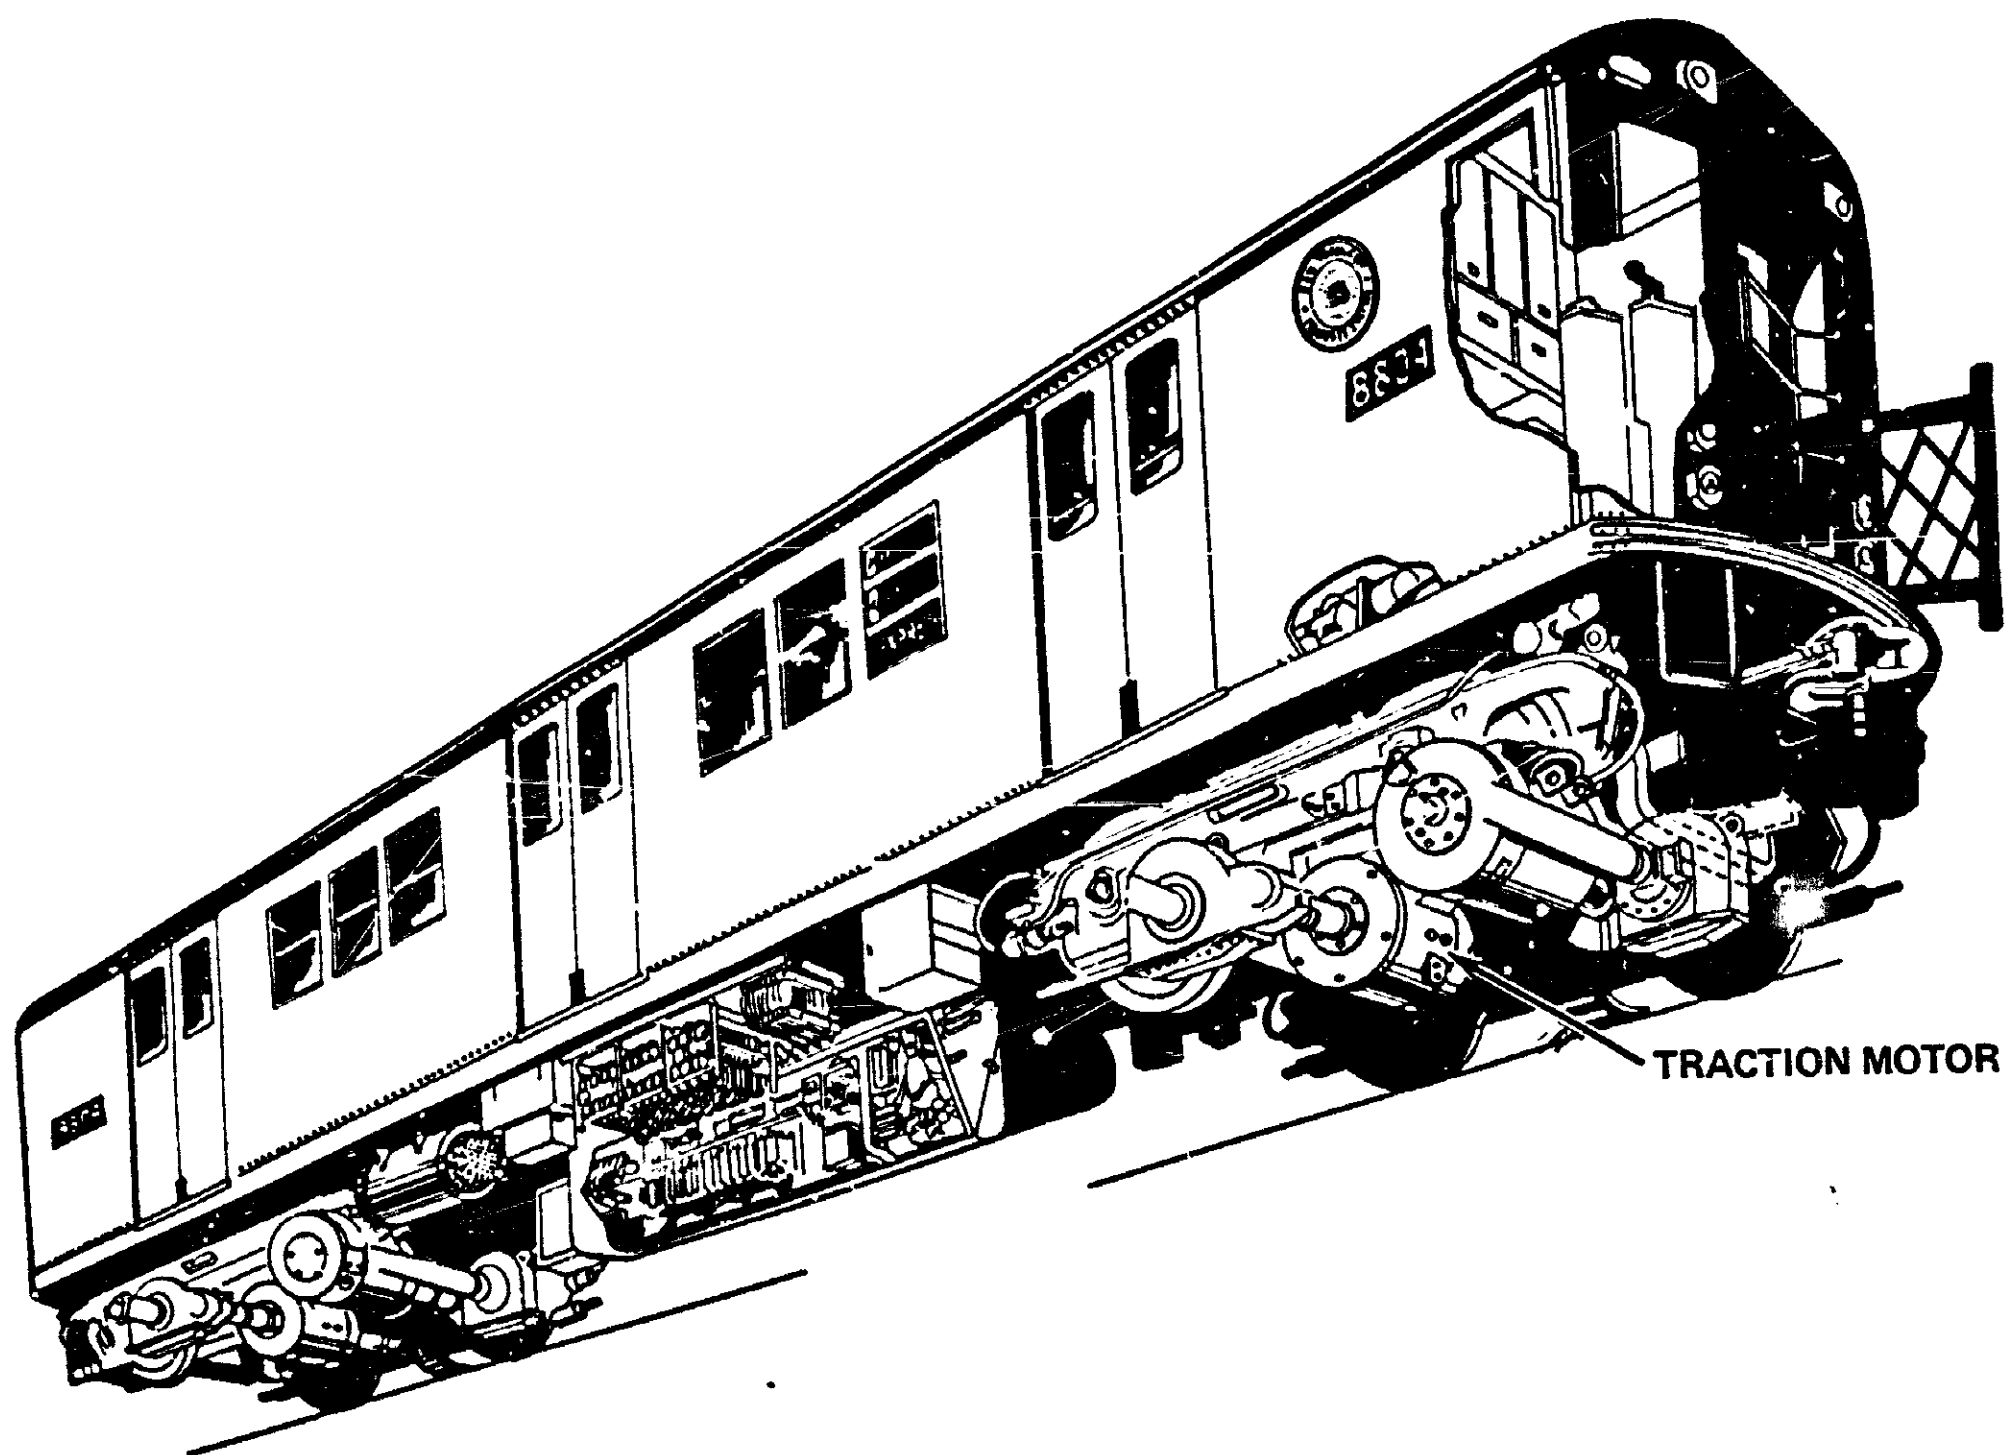
Figure 4.--Diagram of NYCTA subway car
from which traction motor fell on December 15, 1981.

Three of the cars from which the traction motors fell were similar in design. (See figure 4.) The R21 type car involved in the accident on December 15, 1981, was built by the St. Louis Car Company and was put into service in 1956/57. The R29 type car involved in the accident on June 8, 1981, was built by the St. Louis Car Company and was put into service in 1962. The R28 type car involved in the accident on March 7, 1982, was built by the Amcar Division of ACF Industries and was put into service in 1960/61. These cars are 51 feet 1/2 inch long over the antilimbers and 8 feet 9 1/2 inches wide. Four 100-horsepower electric traction motors power the cars through reduction gear boxes pressed onto each axle. Each car is equipped with 44 seats and has a maximum passenger capacity of 200 persons. The car body and framing are constructed of low-alloy, high-tensile steel. The cars are equipped with dynamic and electric pneumatic braking systems. Each car is equipped with a two-way radio, a public address system, and emergency lights; all of this equipment is connected to a 32-volt battery system in the event of loss of power from the third rail.

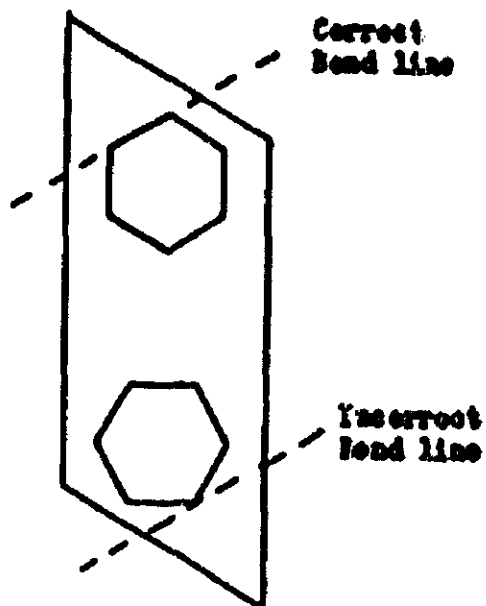
FIGURE 2

When using locking tabs to secure motor foot mounting bolts, bend tab firmly against the flat surface of the bolt head. Bending against the corner of the head will NOT lock bolt. If locking tabs are not used, lockwashers must be used.
